**Humboldt
Redwood™**

**Freshwater Creek
Watershed Analysis Revisited**

September 27, 2018

Purpose: Aquatic Habitat Conservation Plan Trends and Effectiveness Monitoring Report

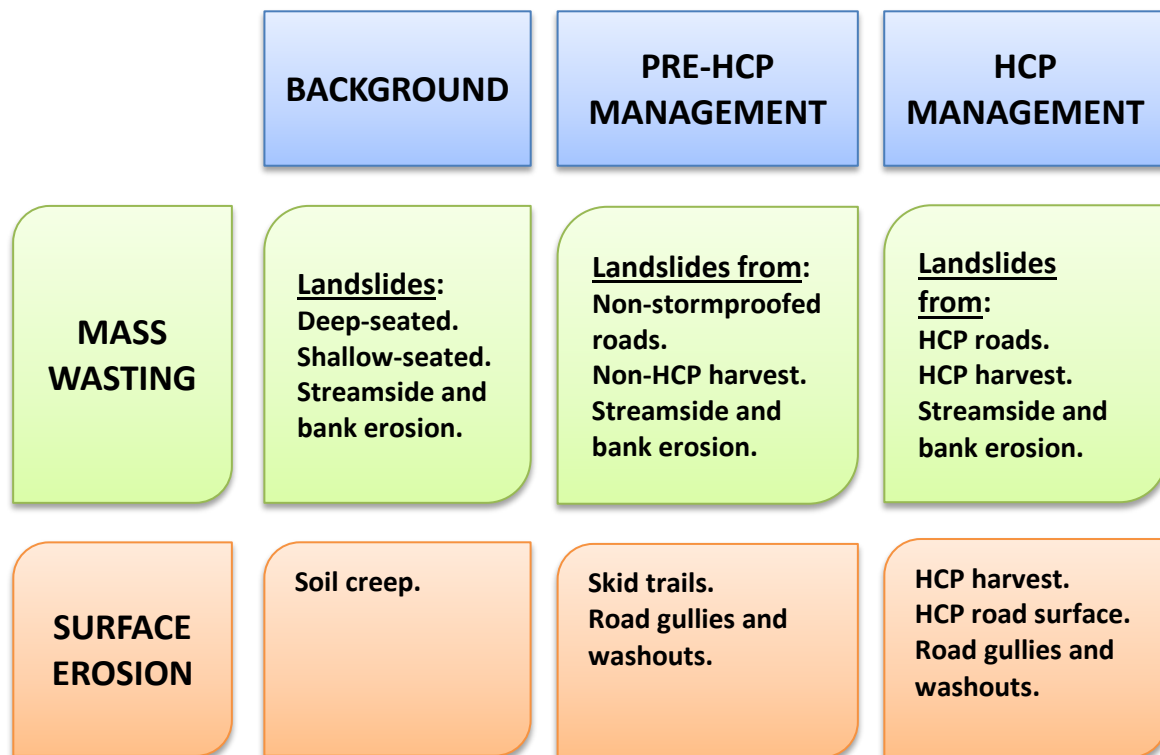
For this analysis, sediment sources are divided into three general categories as presented in the following diagram:

Background sediment sources are those that are part of natural processes with little to no apparent linkage in causal mechanism to land use activities. These include open slope landslides and earthflows on hillslopes occupied by advanced forest regeneration (>15-30 years) and older forests, natural soil creep,

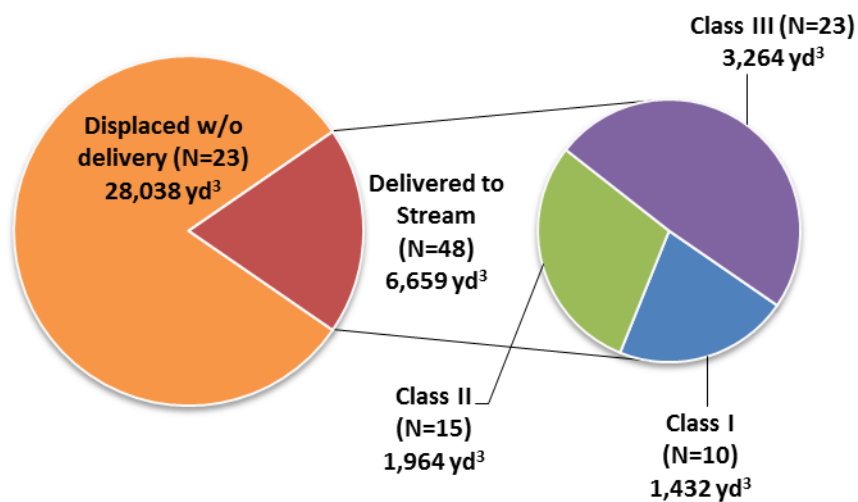
Figure 4-3. Freshwater Creek HRC HCP landslide volume displaced and delivered by stream class (2003, 2006, 2010 aerial photographic analysis)

These near stream points of origin obviously result in a fairly high delivery rate, as 48 of the identified failures discharged sediment directly into a watercourse (Table 4-1). However, less than 20% of the total displaced volume associated with these slides actually entered a mapped watercourse (approximately 6,700 yd³ delivered vs. approximately 34,700 yd³ mobilized) with just over 3,264 yd³ going into Class III watercourses (Figure 4-3). Sixty-eight percent (4,501 yd³) of the total discharged volume came from slides that initiated on streamside slopes (ss) and headwall swales (hw). A significant percentage of this volume (2,400 yd³) was contributed by slides that originated at stormproofed roadways, with another 2,500 yd³ from slides originating from non-HCP (i.e., pre-HCP) harvest areas (Figure 4-4).

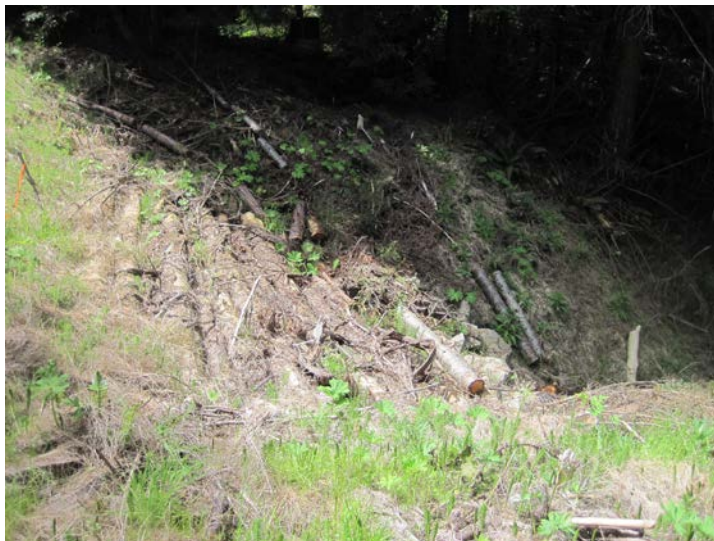
Figure 18. LWD cribbing along outlet fillslope of culvert crossing.

Although not required and formally tracked as a construction specification alternative, HRC tested the incorporation of large wood debris in large culvert crossing fillslopes. In particular geology types, HRC has learned long, steep fillslopes are prone to erosion and failure after the first winter following construction. This adaptive practice is relatively unconventional in terms of standardized fillslope armoring specifications used in the past. When LWD is available, HRC plans to continue using this strategy to armor fillslopes prone to failure (Figures 18-19).

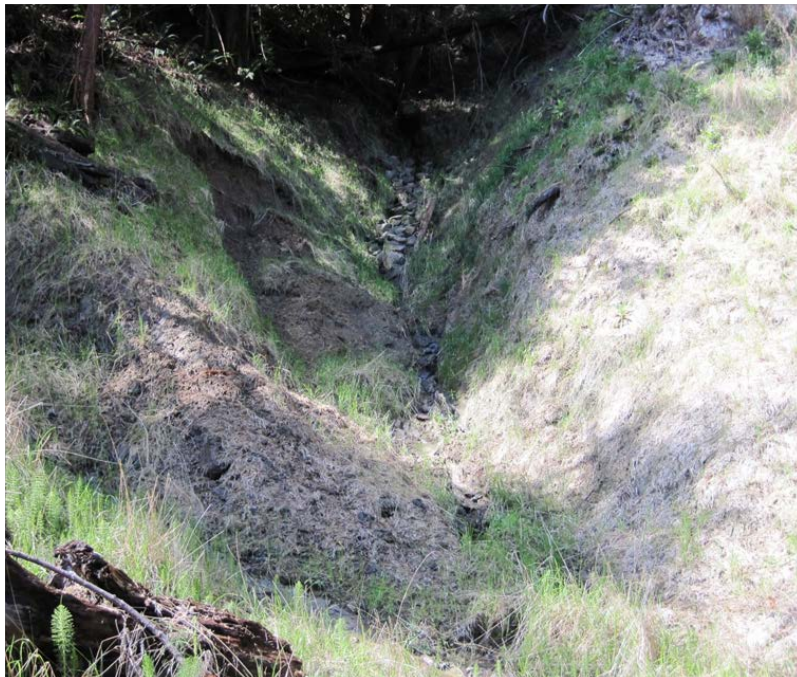
Figure 32. Slope failure adjacent to newly excavated channel.
